Salem Armory Facility Assessment

Salem, South Dakota | February 2020

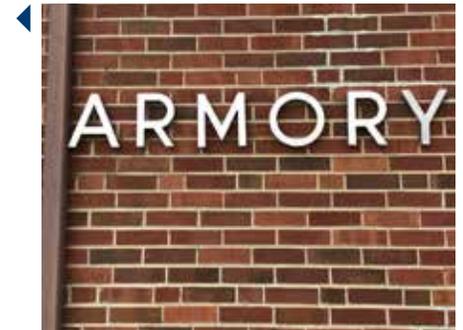
Element	Exterior building signage
Condition	Poor
Details	Signage for Armory is present.
Recommendation	Replace exterior building signage for new use.

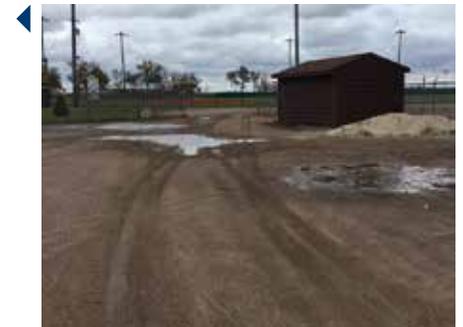
Element	Vehicle circulation around the building
Condition	Fair
Details	Low points are causing some water ponding.
Recommendation	Regrade areas to prevent water ponding.

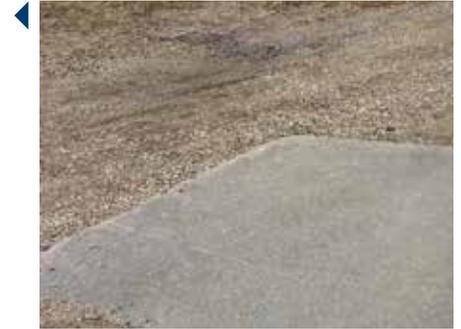
Element	Loading area access
Condition	Poor
Details	The access curb is not extended and has resulted in damage to the grassed area.
Recommendation	Extend the access curb cut to prevent additional damage to grass.

Civil	Exterior Site	Extend loading area access curb cut to prevent additional damage to grass	3	\$4,988

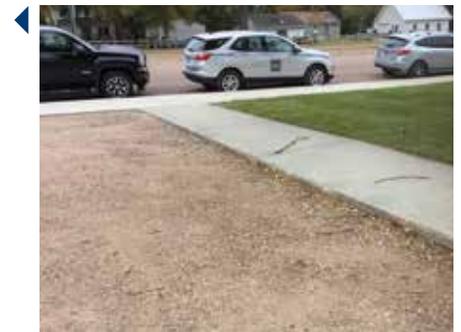
Element	South and west parking lots
Condition	Fair
Details	Parking areas are not paved.
Recommendation	Pave the south and west parking lots to increase parking efficiency and durability

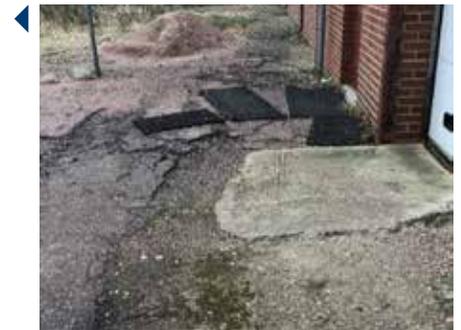
Element	Loading/maintenance lot near overhead door
Condition	Poor
Details	Bituminous pavement is significantly damaged, cracked and crumbled.
Recommendation	Repave parking lot.

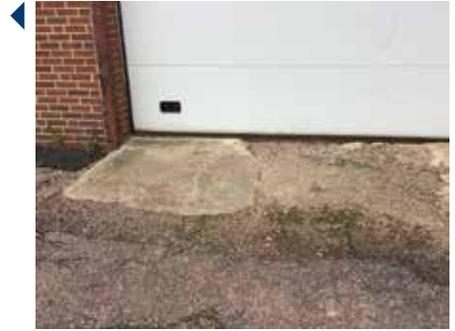
Element	Stoop by overhead door
Condition	Poor
Details	Stoop concrete is cracked, broken, and damaged.
Recommendation	Replace concrete stoop

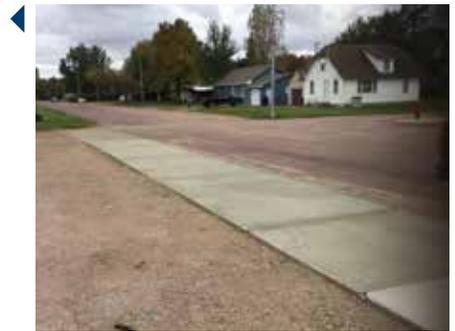
Element	West sidewalk
Condition	Fair
Details	There are no control joints in the concrete walk, which may lead to cracking and heaving.
Recommendation	Replace the west sidewalk and install control joints.

Civil	Exterior Site	Replace sidewalk on west side	3	\$11,638

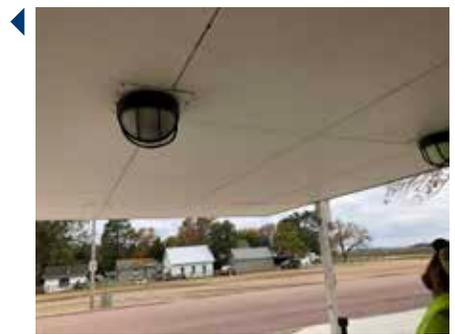
Element	Entrance Canopy
Condition	Poor
Details	Lighting at canopy not functioning.
Recommendation	Replace lighting, or replace entry canopy in its entirety.

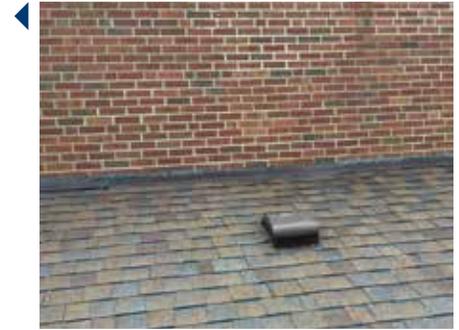
Element	Roof flashing caulk, sealant at the sloped section
Condition	Poor
Details	The flashing at the top of the wood roof joists is not properly sealed to the brick wall. This has allowed water intrusion, leading to roof and wall damage.
Recommendation	Remove and replace roof flashing where deteriorated. Remove caulking/sealant between flashing and brick wall. Install proper caulking to provide a water tight seal. Continue to monitor the roof for leaks along the entire sloped roof section ensure flashing is performing adequately.

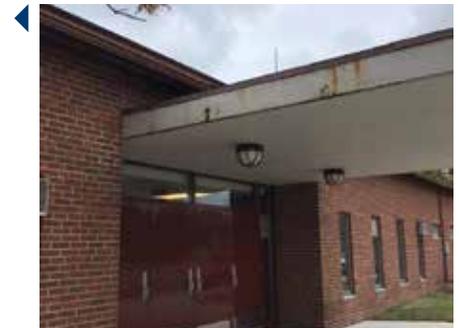
Element	Canopy
Condition	Poor
Details	Canopy is rusted
Recommendation	Repair and repaint canopy (short-term plan). Replace canopy (long-term plan).

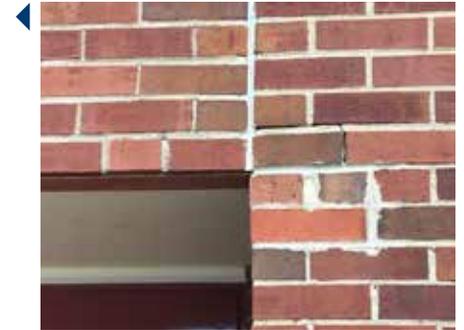
Element	Mortar joints on brick exterior walls
Condition	Fair
Details	Mortar has crumbled and is no longer filling all joints adequately.
Recommendation	Tuckpoint walls on approximately 60% of the exterior brick.

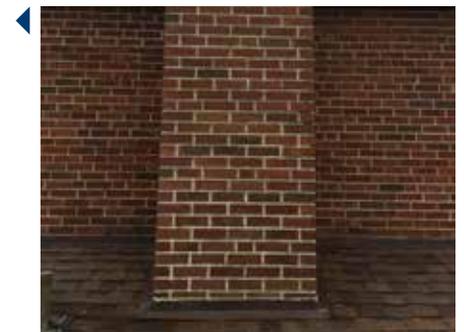
Element	Mortar joints on brick chimney walls
Condition	Fair
Details	Mortar has crumbled and is no longer filling all joints adequately.
Recommendation	Tuckpoint walls on brick chimney.

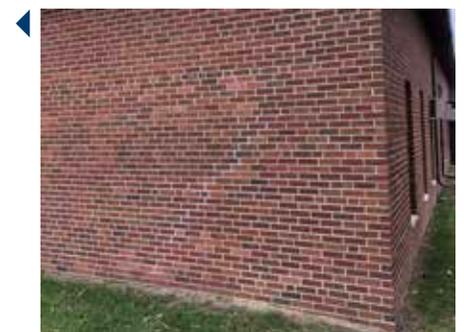
Element	Section of exterior wall.
Condition	Poor
Details	There is an area of approximately 250 square-feet that has damage to the brick including caulk and control joints that have degraded. This can lead to water intrusion and damage.
Recommendation	Replace caulk in brick wall with mortar, tuckpoint, add control joints.

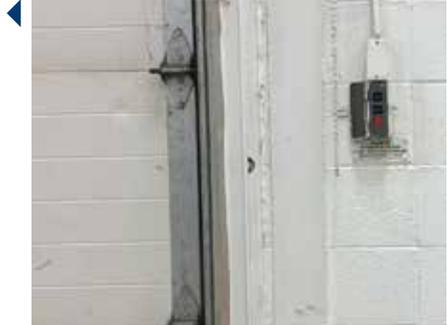
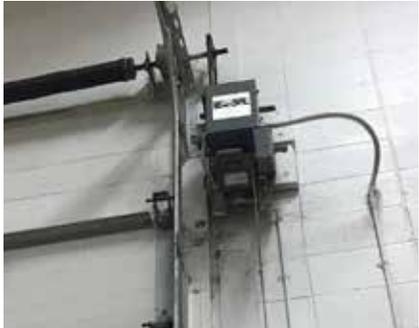
Element	Overhead door
Condition	Fair
Details	The overhead door is in working order but lacks a safety stop.
Recommendation	Replace the overhead door and install a safety stop.

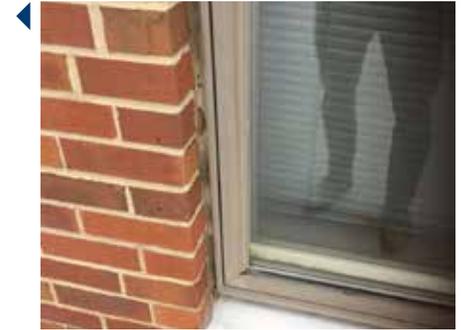
Element	All exterior windows
Condition	Poor
Details	Water and weather intrusion is occurring at exterior windows due to a poor seal. The caulk has deteriorated and is no longer useful.
Recommendation	Reseal the exterior windows.

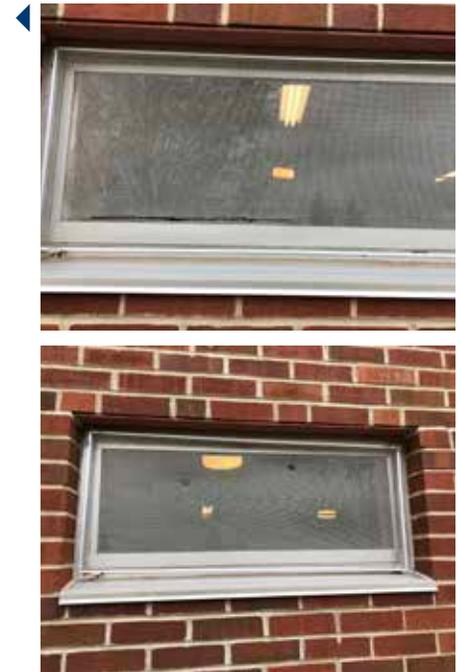
Element	Window screens
Condition	Fair
Details	Screens are working but some show signs of wear, stretching, and have holes.
Recommendation	Replace wire mesh screens over windows.

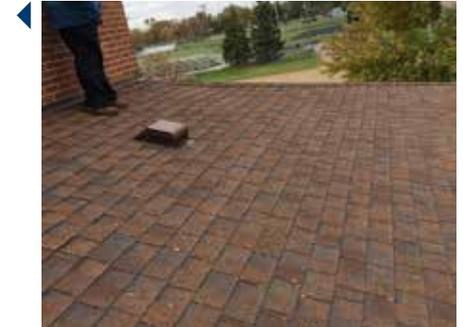
Element	Roof
Condition	Fair
Details	There are a significant amount of divots on the roofing surface.
Recommendation	Investigate the roof divots and repair as needed.

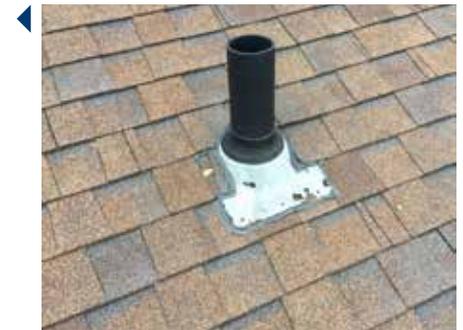
Element	Vent pipe boot on roof
Condition	Poor
Details	Vent pipe boot is damaged.
Recommendation	Remove and replace vent pipe boot.

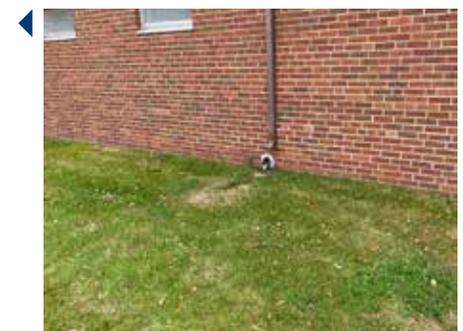
Element	Roof drain
Condition	Fair
Details	The roof drain was abandoned and left in place.
Recommendation	Remove the roof drain when the roof is replaced.

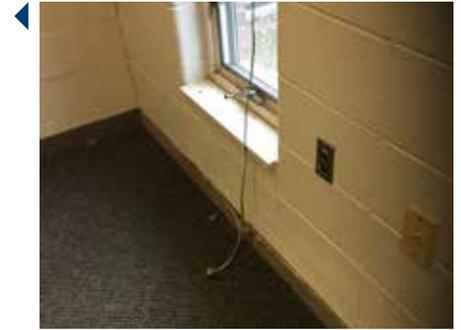
Element	Carpet in rooms 104, 105, 108, 109
Condition	Fair
Details	Carpet is usable, however it shows signs of wear with stains and worn areas.
Recommendation	Replace the carpet.

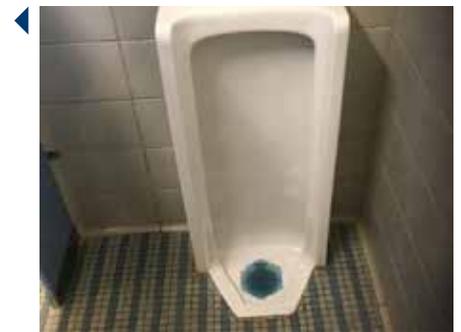
Element	Tile in locker room
Condition	Fair
Details	Tile is in working condition but is outdated.
Recommendation	Remove the floor tile.

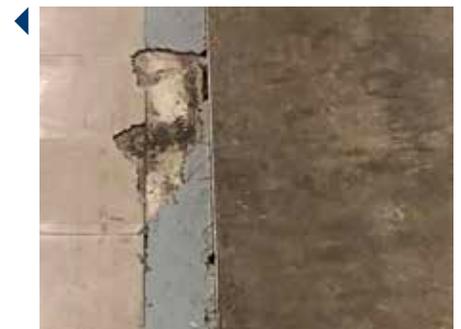
Element	Tile in room 101 (gymnasium)
Condition	Poor
Details	Tile floor is damaged and has surpassed its useful life, and contains asbestos.
Recommendation	Replace the gymnasium floor with wood flooring.

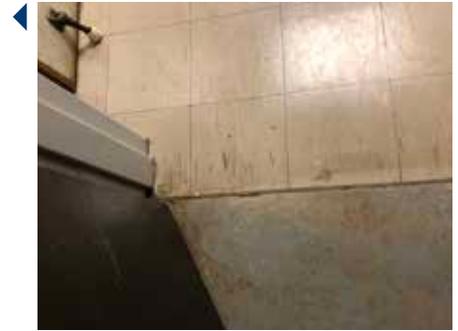
Element	Room 106, 107, 119, 122, 122A, 123, 125-128
Condition	Poor
Details	Floor tile is outdated, damaged, and contains asbestos at some locations.
Recommendation	Install Luxury Vinyl Tile (LVT) flooring.

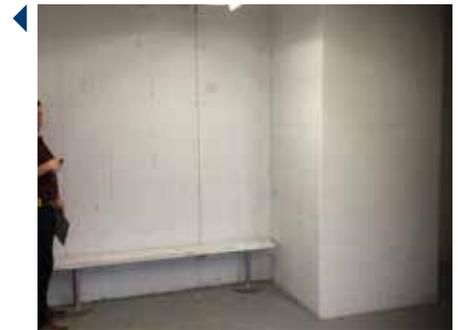
Element	Room 110, 113 (locker rooms)
Condition	Poor
Details	Flooring is uneven and damaged at various locations.
Recommendation	Install ceramic floor tile with leveling base layer.

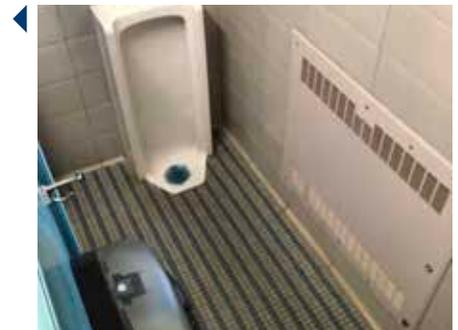
Element	Rooms 111, 112, 115, 117, 118
Condition	Poor
Details	Floor tile is dated and damaged. Grout is aging and has surpassed its useful life.
Recommendation	Replace floor tile with ceramic floor tile.

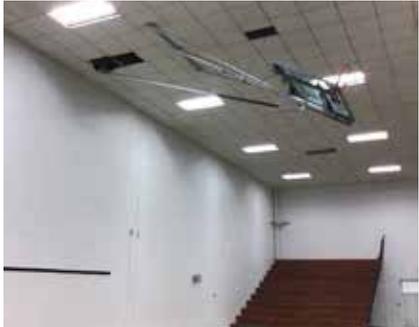
Element	Room 101 walls
Condition	Fair
Details	The room is used as a gym and there is a short distance from the play area to the wall. Safety measures including padded walls is a proactive safety measure.
Recommendation	Install padded mats at each end of the gym.

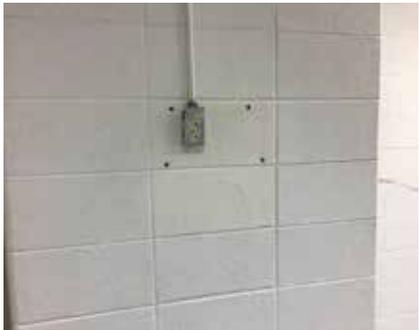
Element	Interior wall including all rooms for the exception of the offices, 106, (4' of 107, 115, 117)
Condition	Fair
Details	Existing paint is dated, scuffed, and has minor damage.
Recommendation	Paint all interior walls.

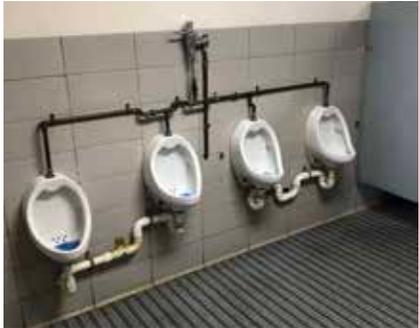
Element	Rooms 107, 115, 117 and 123
Condition	Fair
Details	Existing walls are dated, scuffed, and have minor damage. Installing ceramic tile will prevent further damage, improve clean-ability, durability, and aesthetics of walls.
Recommendation	Install ceramic wall tile to bottom five-feet of room 107, 115, and 117; and bottom 9-feet of room 123.

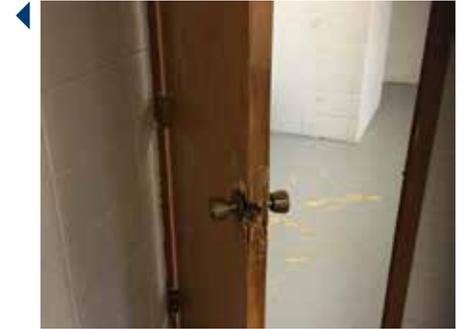
Element	All interior wood doors
Condition	Poor
Details	Interior wood doors are damaged and require replacement. Door knobs are not ADA compliant.
Recommendation	Replace all wood doors with ADA accessible door levers.

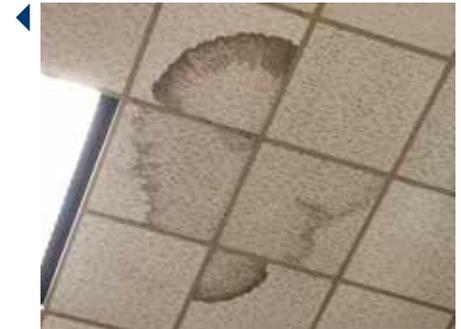
Element	Ceiling tile in room 101 (Gymnasium)
Condition	Poor
Details	Tile is damaged, stained, and may contain asbestos.
Recommendation	Remove ceiling tile and grid (leave exposed). Paint the ceiling structure.

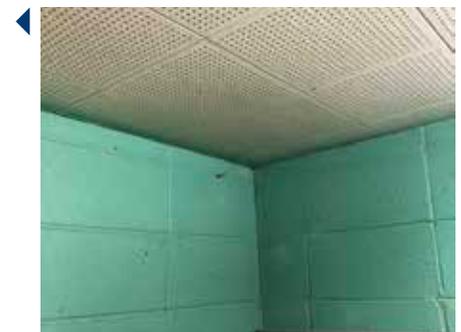
Element	Ceilings in rooms 102, 110-113, 119
Condition	Poor
Details	Rooms lacking ceiling.
Recommendation	Install ACT tile and grid.

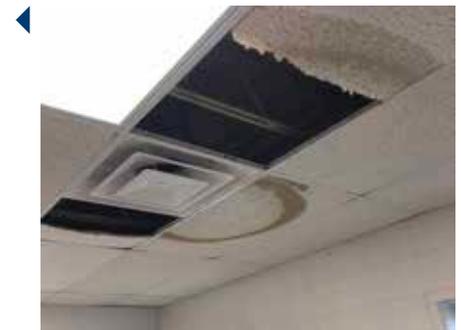
Element	Ceilings in rooms 103-109,122,122A, 123, 128
Condition	Poor
Details	Approximately 5% of the ceiling tiles are damages or stained.
Recommendation	Replace 5% of the ACT tiles (ceiling grid to remain)

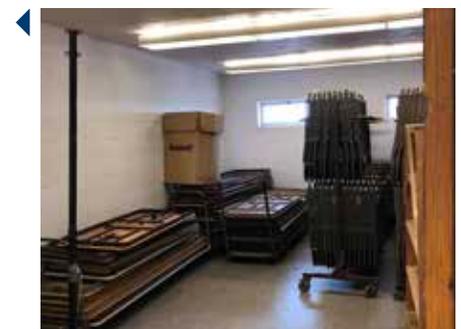
Element	Ceiling tiles in rooms 115, 117, 125, 126
Condition	Fair
Details	Gypsum board ceilings are marked up and damaged in some locations
Recommendation	Patch and Repaint the ceiling as needed.

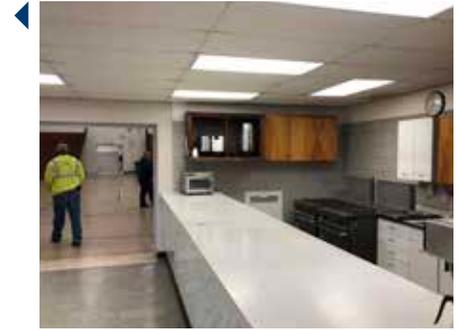
Element	Room 123, kitchen cabinets and countertops
Condition	Poor
Details	Cabinets are mismatched, are missing doors, laminate counter is damaged, and counter is not an accessible height.
Recommendation	Replace kitchen cabinets and countertops.

Architecture	Kitchen	Replace kitchen cabinets and countertop	3	\$25,077

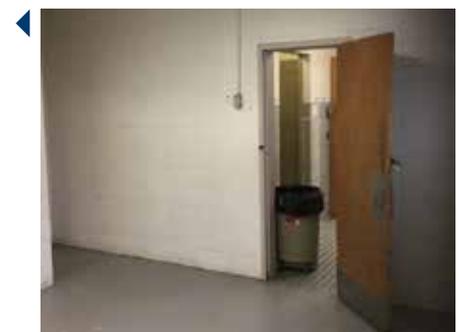
Element	Room 110 and 113 (locker room)
Condition	Fair
Details	There are currently no lockers installed in the room. The layout is not ideal for use as a community locker room.
Recommendation	Install steel lockers. Adjust layout to accommodate future needs.

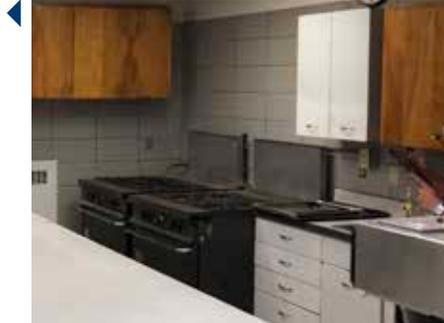
Element	Room 123, kitchen equipment (stove, oven, coffee maker)
Condition	Fair
Details	The kitchen equipment is in working order but is outdated and has passed its useful life.
Recommendation	Replace kitchen equipment including the stove, hood, oven, coffee maker, etc.

Architecture	Kitchen	Replace kitchen equipment (stove, oven, coffee maker, etc.)	3	\$19,950

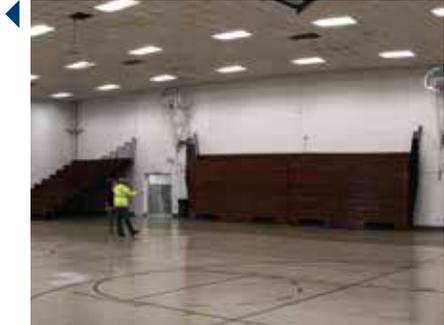
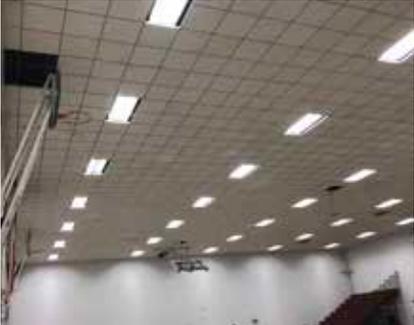
Element	Gymnasium equipment
Condition	Fair
Details	Basketball hoops and bleachers are outdated and have minor damage.
Recommendation	Replace the basketball hoops and bleachers.

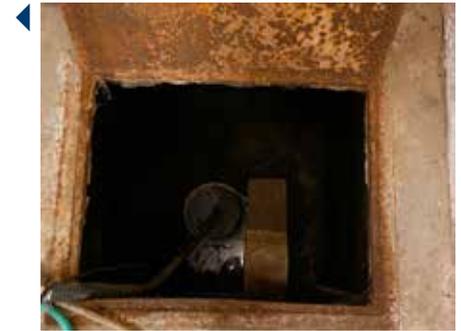
Element	Sump pump
Condition	Poor
Details	Sump pump does not work properly.
Recommendation	Replace sump pump and controls.

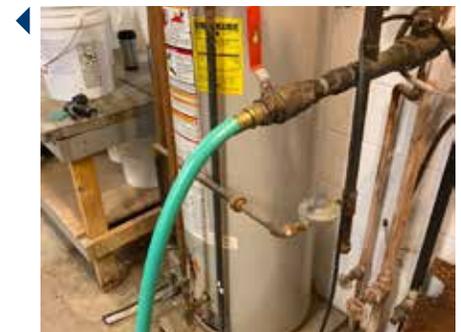
Element	Hose connections
Condition	Poor
Details	The hose connections do not have vacuum breakers.
Recommendation	Install vacuum breakers.

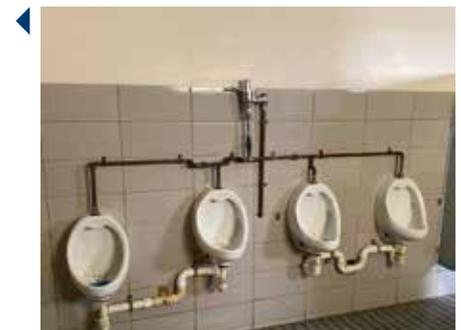
Element	Men's restrooms
Condition	Fair
Details	Urinals are on one flush valve which is a slow acting valve and consumes unnecessary water.
Recommendation	Install flush valves on urinals.

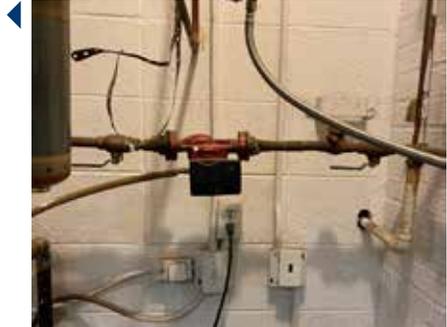
Element	Water heater and recirculation pump
Condition	Fair
Details	Water heater—installed in 2004—and recirculation pump are in working order.
Recommendation	Replace the water heater and recirculation pump within 5 years.

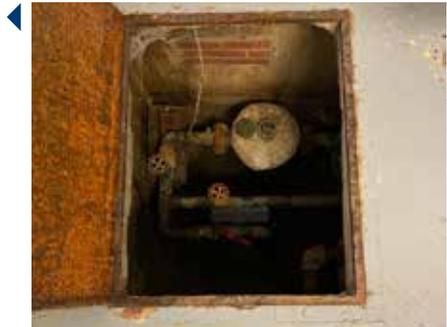
Element	Water distribution tunnel
Condition	Fair
Details	The tunnel has moisture and high humidity.
Recommendation	Install ventilation a ventilation system.

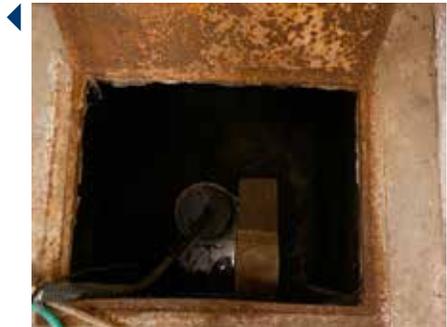
Element	Sump pump and controls
Condition	Poor
Details	The sump pump and controls are not operating properly.
Recommendation	Replace the recirculation pump.

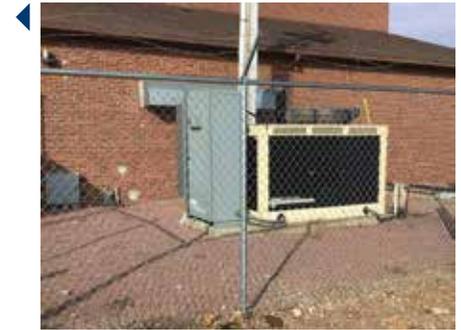
Element	Emergency generator
Condition	Fair
Details	The system is run on LP gas. There is a connection for the generator for the front portion of the building.
Recommendation	Perform regular maintenance.

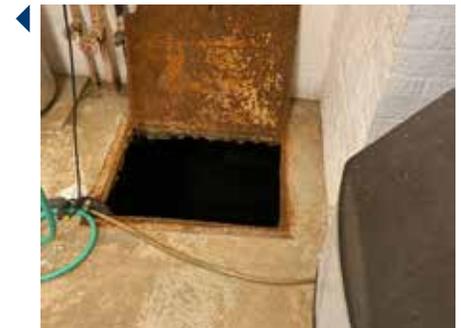
Element	Perimeter tunnel access
Condition	Fair
Details	Appears to be accessible.
Recommendation	Perform regular maintenance.

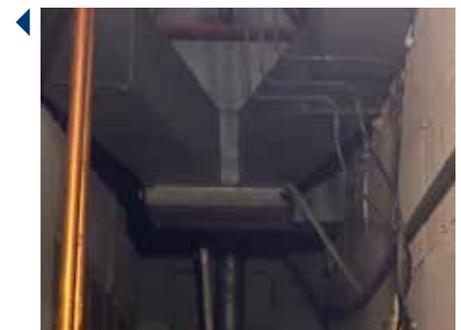
Element	Restroom exhaust fans (2)
Condition	Poor
Details	The fans are not functioning.
Recommendation	Replace the inoperable exhaust fans in the restrooms.

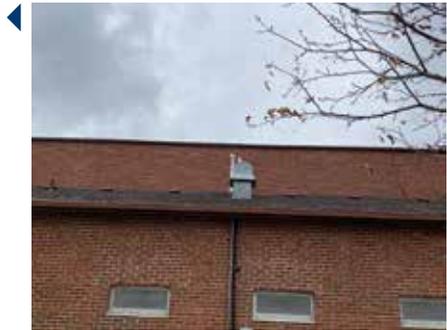
Element	Roof exhaust fan
Condition	Poor
Details	The exhaust fan has been abandoned and is no longer needed.
Recommendation	Remove the exhaust fan and cap at the roof.

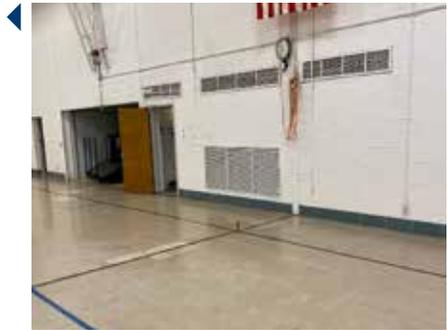
Element	Supply and return air for gymnasium
Condition	Fair
Details	This system is not ideal for proper air distribution.
Recommendation	Replace the air supply for the gymnasium when other mechanical systems are upgraded.

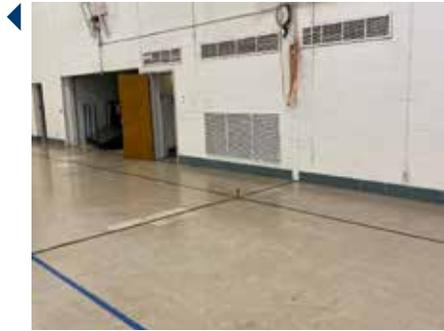
Element	Gymnasium exhaust grilles
Condition	Fair
Details	System appears to be in working order.
Recommendation	Perform regular maintenance.

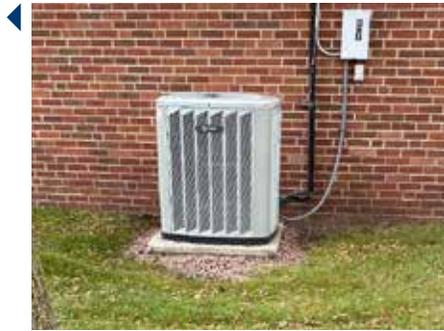
Element	Northwest and southwest HVAC condensing unit
Condition	Fair
Details	System appears to be in working order.
Recommendation	Perform regular maintenance.

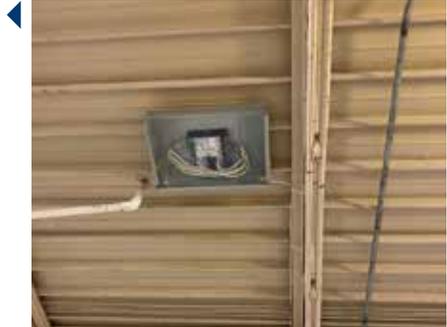
Element	South furnace controller
Condition	Fair
Details	Cover is missing. System appears to be in working order.
Recommendation	Replace cover and perform regular maintenance.

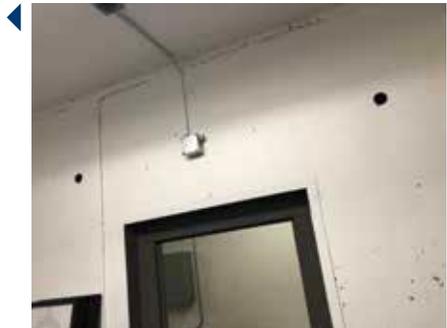
Element	Old vault
Condition	Poor
Details	There is no ventilation, heating, or cooling in this area.
Recommendation	Perform regular maintenance.

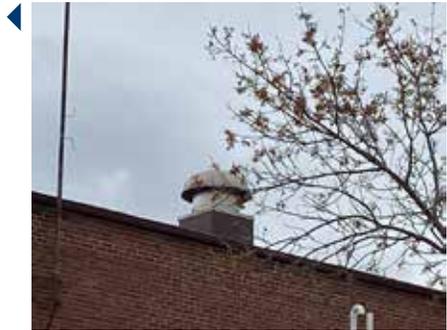
Element	Exhaust system in the gym
Condition	Poor
Details	Maintenance staff is unaware of how to turn the exhaust on or off, or where the controls are located.
Recommendation	Replace the gym fan with a new fan and controls.

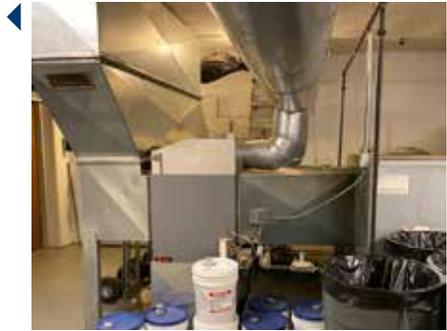
Element	Air handling unit (AHU) I
Condition	Good
Details	The AHU appears to be in working order.
Recommendation	Perform regular maintenance

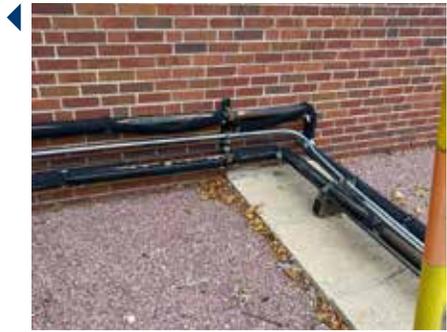
Element	Air handling unit (AHU) I refrigeration line
Condition	Poor
Details	The refrigeration line insulation is damaged or missing.
Recommendation	Install new insulation line.

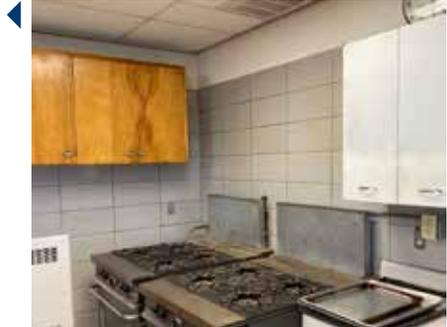
Element	Kitchen exhaust
Condition	Poor
Details	There is no grease-rated exhaust fan, hood, or ductwork.
Recommendation	Install a grease hood, ductwork, and exhaust in the kitchen.

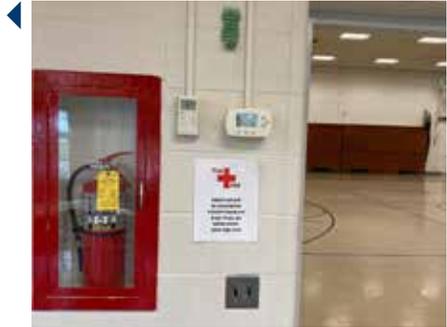
Element	Thermostat
Condition	Fair
Details	There is a new split system timer on the thermostat.
Recommendation	Perform regular maintenance.

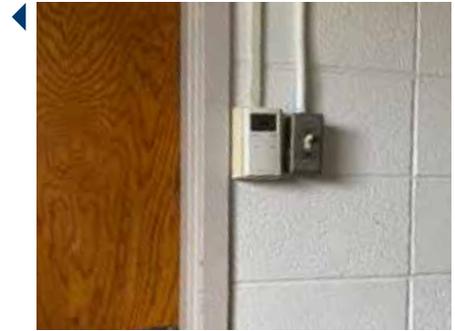
Element	Override thermostat for west, south, and north HVAC units
Condition	Fair
Details	Systems appear to be in working order.
Recommendation	Perform regular maintenance.

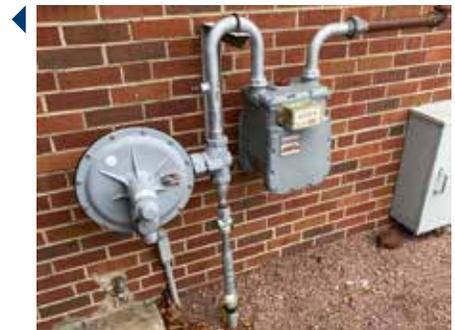
Element	Natural gas meter
Condition	Good
Details	One and a half-inch 2 PSI. System appears to be in working order.
Recommendation	Perform regular maintenance.

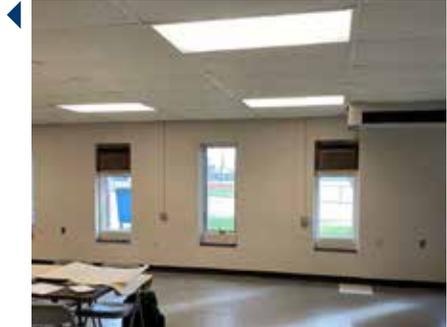
Element	Window air conditioners and split system
Condition	Fair
Details	A/C system appears to be in working order.
Recommendation	Perform regular maintenance

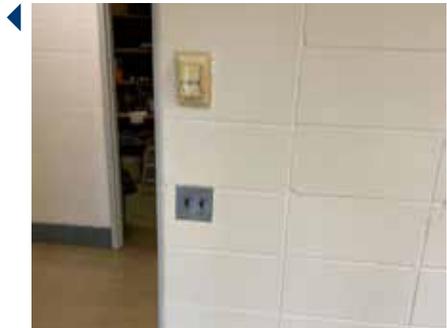
Element	Hot water heat pneumatic controls
Condition	Poor
Details	The previous pneumatic controls for hot water heat have been abandoned and left in place throughout the building.
Recommendation	Remove the pneumatic controls.

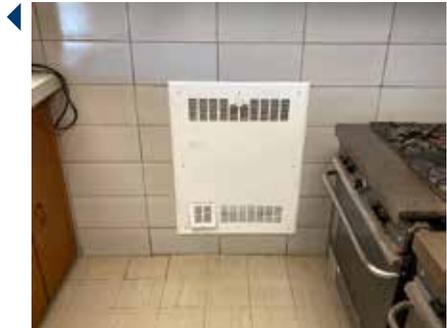
Element	Hot water cabinet in the kitchen
Condition	Poor
Details	The hot water cabinet was abandoned and left in place.
Recommendation	Remove the abandoned hot water cabinet.

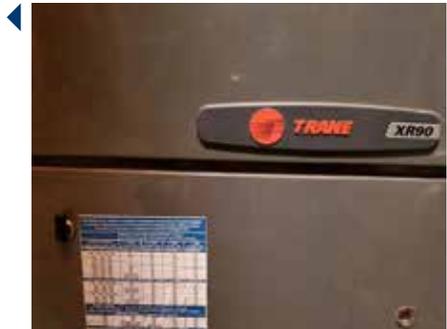
Element	Mechanical furnace
Condition	Good
Details	The Trane XR90 system appears to be in working order.
Recommendation	Perform regular maintenance.

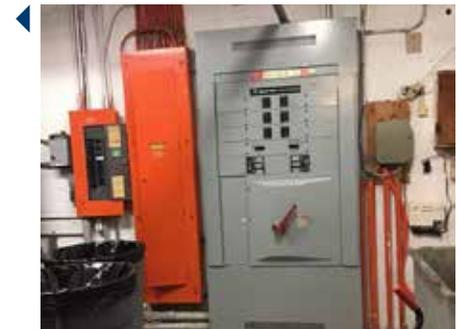
Element	Main electrical switchgear
Condition	Good
Details	System appears to be working adequately. No further investigation was conducted as part of this assessment.
Recommendation	Perform regular maintenance.

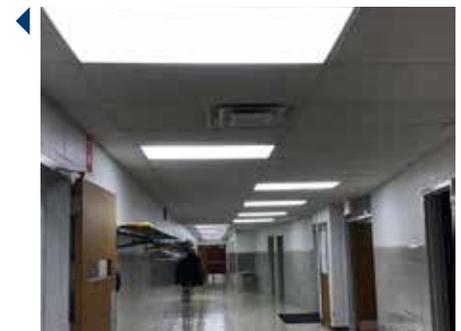
Element	Lighting
Condition	Fair
Details	Lighting levels appear adequate for a majority of the spaces. Light levels in the gymnasium are low. Light fixtures are dated and inefficient.
Recommendation	Upgrade the lighting to LED for energy efficiency.

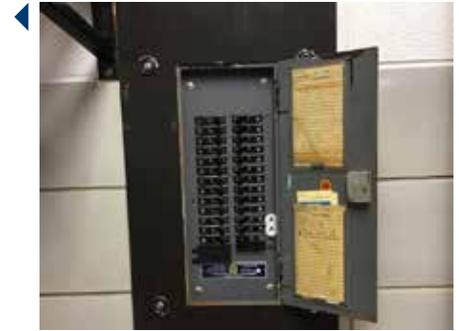
Element	Square D panelboards
Condition	Fair
Details	System appears to be in working order.
Recommendation	Perform regular maintenance.

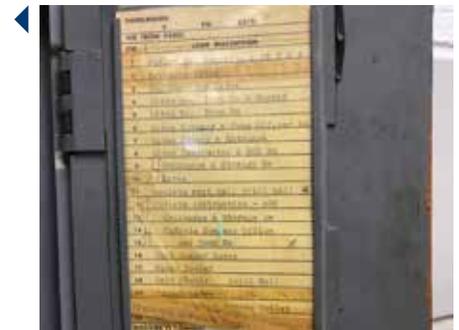
Element	Square D panelboards
Condition	Fair
Details	System appears to be in working order.
Recommendation	Perform regular maintenance.

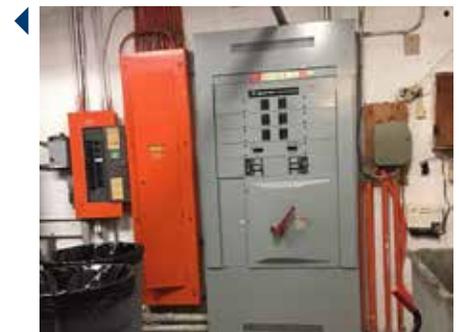
Element	Main panel
Condition	Good
Details	Spectra series panelboards
Recommendation	Perform regular maintenance.

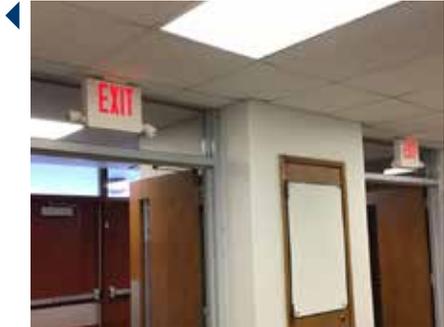
Element	Emergency egress signage and lighting
Condition	Good
Details	Emergency egress signage and lighting appear to be in working order.
Recommendation	Perform regular maintenance.

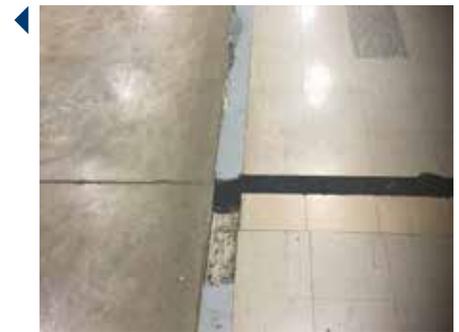
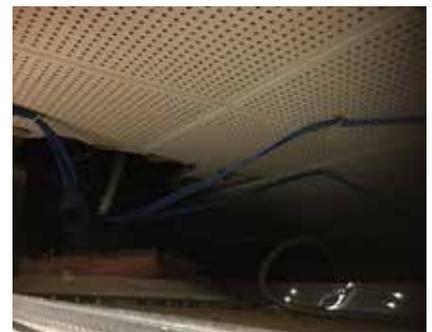
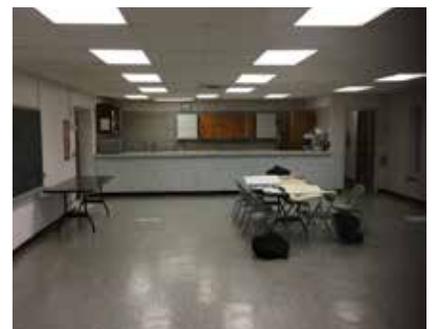
Asbestos/lead

Element	Tile in rooms 101, 107, 122, 122A, 123, 125-128
Condition	Fair
Details	Due to the age of the original construction and the particular size and type of tile, asbestos concerns exist within the facility.
Recommendation	Remove tile per Pollution Control Agency regulations since asbestos containing materials and lead are harmful when disturbed.

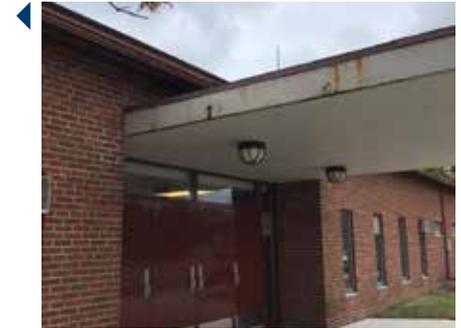
Element	Room 106 entrance
Condition	Poor
Details	There is a 1" drop at door threshold
Recommendation	Replace entry stoop and install automatic ADA actuator.

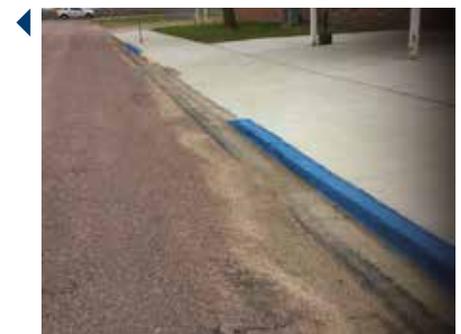
Element	ADA accessible parking stalls
Condition	Poor
Details	Striping is faded or missing to indicate stall area.
Recommendation	Add parallel parking striping at ADA accessible stalls.

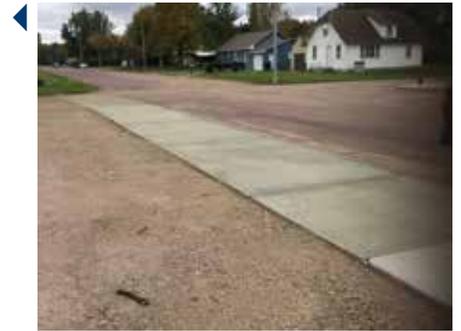
Element	Cross walk from Peck Street
Condition	Fair
Details	There is no crosswalk to the building from Peck Street.
Recommendation	Add a crosswalk between the Armory and the west parking lot.

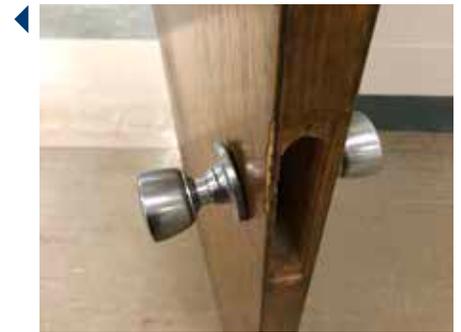
Element	Doors
Condition	Poor
Details	Wood doors have old locks, holes from removed hardware, and are in a degraded condition.
Recommendation	Replace all interior wood doors.

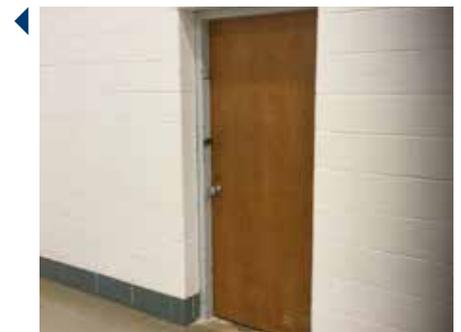
Element	Door hardware
Condition	Poor
Details	Door hardware is traditional round knobs, which are not ADA accessible.
Recommendation	Replace all door hardware with ADA accessible lever hardware.

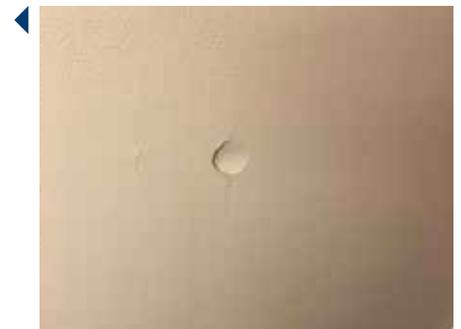
Door Stops/Bumpers

Element	Door Stops / Bumpers
Condition	Poor
Details	Doors are lacking door stops and bumpers and have damaged the adjacent walls.
Recommendation	Install door stops / bumpers on all interior doors.

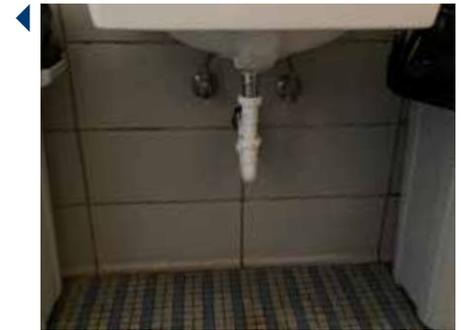
Element	Piping
Condition	Poor
Details	There is no insulation wrap on sink pipes.
Recommendation	Install insulation on sink pipes for ADA-compliance.

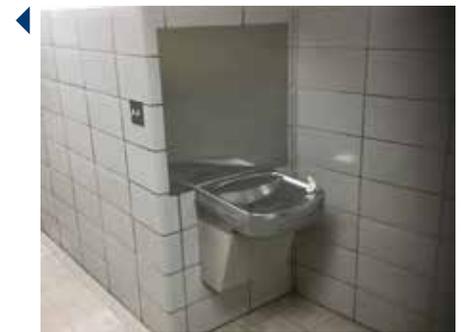
Drinking Fountains

Element	Drinking fountain
Condition	Good
Details	Drinking fountain is in working order
Recommendation	Perform routine maintenance. Consider installing bottle filler in the future.
